# CentrePort Wellington: Resilient regeneration activity

*P. Terry; A. Delaney*

CentrePort, Wellington.

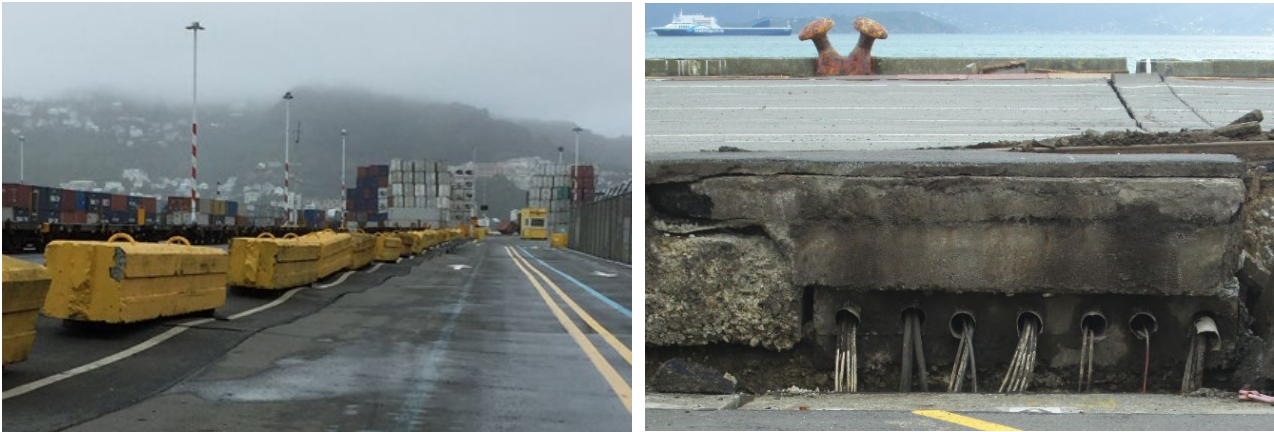
*Figure 2: Some triage-stage observations: settlement, impact of buried structures, unstable containers, tilted light poles, exposed services, structural damage, operations on hold, ships at anchor.*
