# Developments in the use of high-resolution point cloud data to inform heritage restoration

*T. Lamberts & J. Alexander*

Holmes Consulting LP, Christchurch.

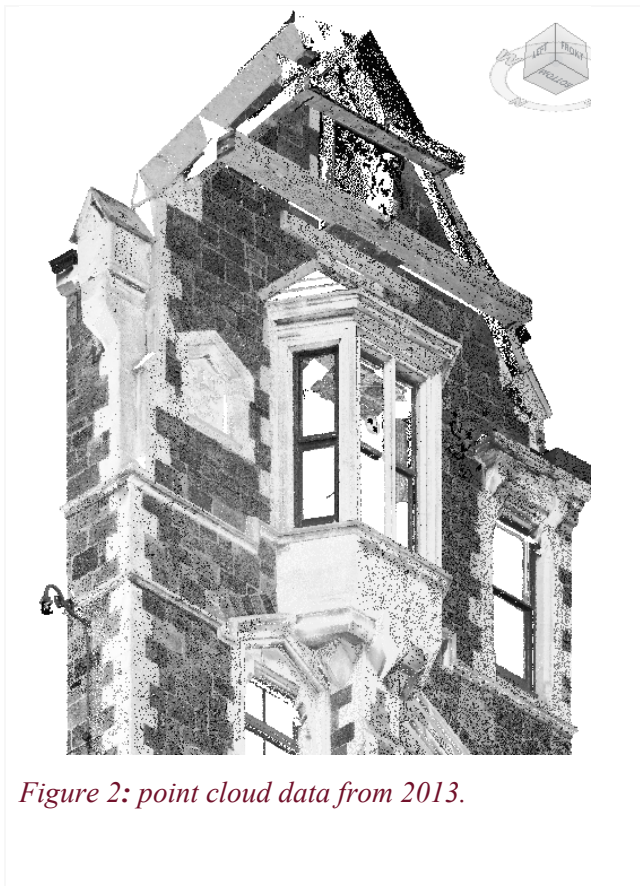
*Figure 2: point cloud data from 2013.*

With advancements in scanning technology, point cloud graphics moved from greyscale to full colour, dramatically improving our ability to interpret the data. Figures 2 and 3 show a comparison of clouds from 2013 and 2018, imported into Revit – a BIM authoring application that has the ability to import and interrogate point cloud data. This increase in definition has not only increased our ability to measure and locate elements, it has enhanced our ability to view the condition of scanned elements to a similar level as a photograph would. The shape and material can now be quickly and clearly identified in an office environment, reducing the reliance on site investigation to verify the point cloud data with associated time and cost savings.

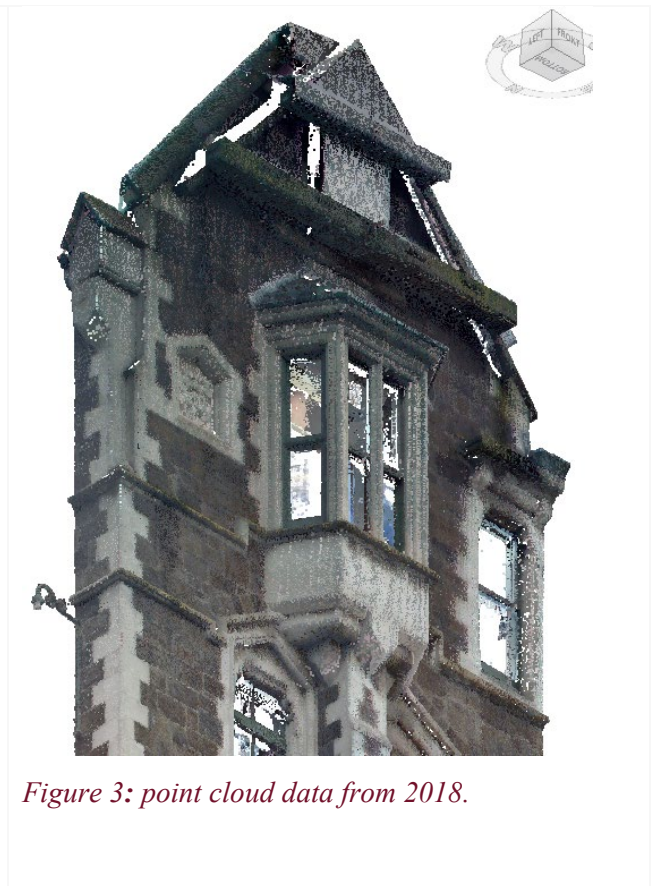
*Figure 3: point cloud data from 2018.*

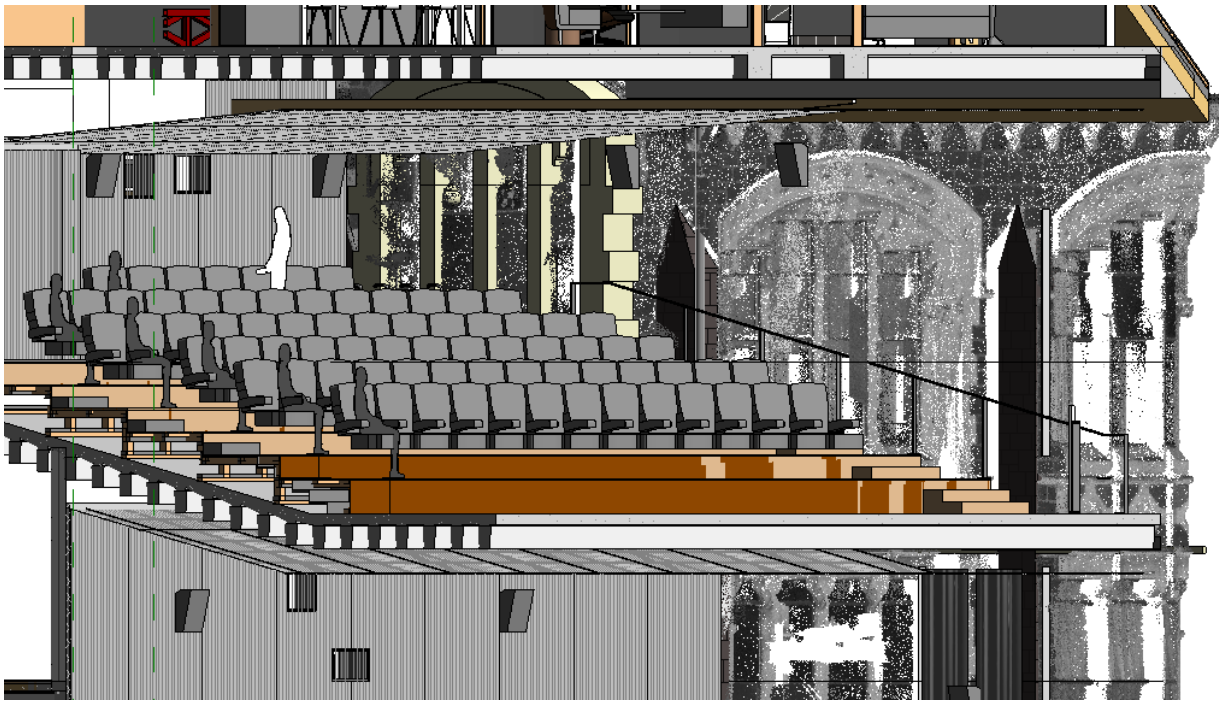
*Figure 5: Coordinating with compliance constraints using point clouds in Revit.*

In a heritage restoration project, if a wall is not plumb or not parallel with the opposite wall, causing a room to be trapezoidal, this information might need to be reviewed for compliance constraints. For example, a boutique cinema in a heritage building will need to have rows of seating of a specified dimension, and an access walkway of a specified dimension (Figure 5).

Using high quality point cloud data as an accurate representation of the existing condition of the walls engineers can identify and coordinate with the narrowest point in the room and set our design constraints accordingly. The drawings may still represent an orthogonal existing structure, but the tolerance can be accounted for through either min. or max. dimensions, or with specific notes on the design constraints, communicating coordination decisions to the contractor.
