Seismic structural monitoring in Wellington using advanced seismological techniques

C. Francois-Holden

SeismoCity Ltd, Wellington.

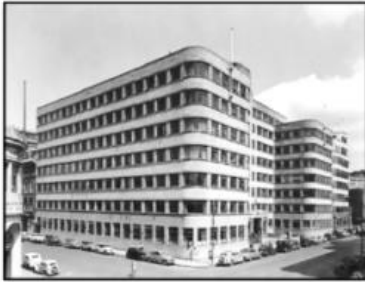
1920s two-way structural steel moment frame structure encased in reinforced concrete and of government level importance (IL3).

Figure 1: Two Wellington buildings with different construction typologies and part of the GeoNet Building Instrumentation Programme chosen for the S2HM analysis.

MBIE Stout Street is an interesting example of a robust 1920s concrete encased structural steel moment frame structure with an elevated importance level (IL3) based on its government department tenancy. The building instrumentation consists of 16 seismic sensors spread across the 8 levels plus basement of the building (Chandramohan et al., 2017). Eight of these sensors are conveniently arranged in a vertical array configuration along the central part of the building. As part of an initial analysis to detect potential structural changes from past earthquakes we have exclusively focused on the sensor vertical array. Future work will include data analysis from the other sensors in order to provide a more detailed 3D response of the structure.

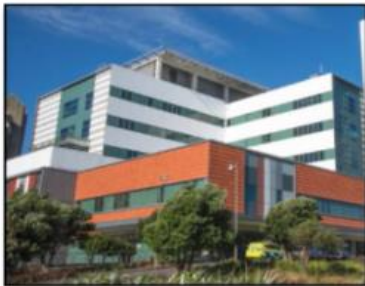
Wellington Regional Hospital

modern base-isolated structure showcasing a damage avoidance system and a high importance level (IL4) designed for post disaster functionality.

Wellington Regional Hospital, a modern base-isolated structure, showcases a damage avoidance system designed to a high importance level (IL4) for post disaster functionality. The building instrumentation consists of 16 seismic sensors spread across the 7 levels of the building (Uma et al., 2011). Seven of these sensors are conveniently arranged in a vertical array configuration, spanning across the 7 floors, located to the southernmost end of the building. As part of an initial analysis to detect potential structural changes from past earthquakes we are exclusively focusing on the vertical array sensors for this study. Future work will include data analysis from the 9 other sensors in order to provide a more detailed 3D response of the structure.

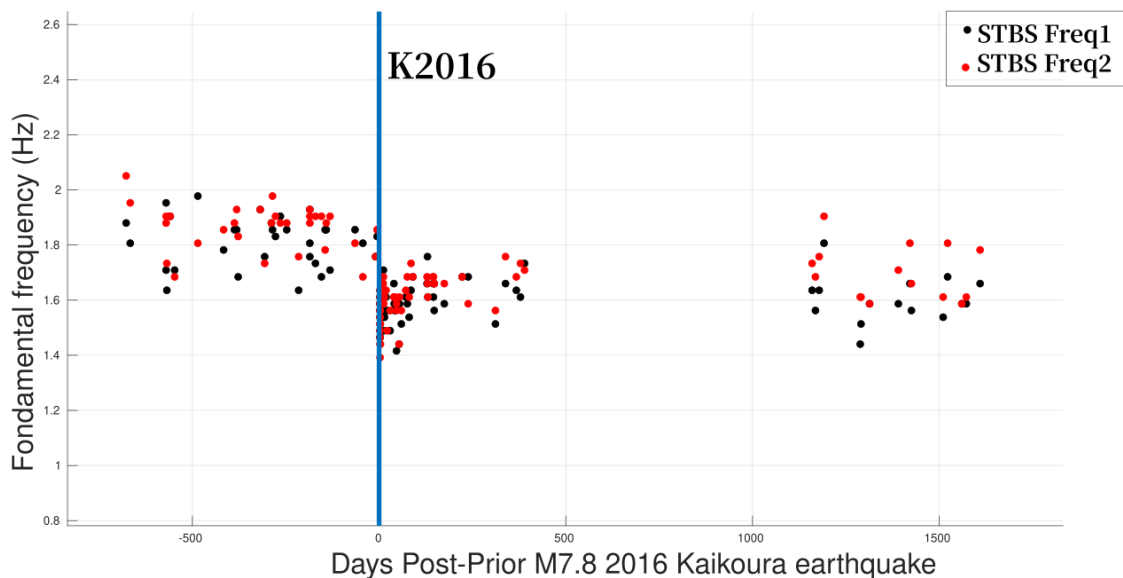
Figure 3: Measurement of the fundamental frequency in the 325 degree direction (Freq1 in black) and the 55 degree direction (Freq2 in red) of the Stout Street building (STBS) against days before and after the 2016 Kaikoura earthquake (day 0) marked by the blue line.

Figure 3 presents computed fundamental frequencies as a function of time (ie days prior to and post the 2016 M7.8 Kaikoura earthquake). Initial frequencies in the 325 degree direction and the 55 degree direction are similar at about 1.9Hz (0.53sec). This is consistent with the symmetrical shape of the Stout Street building. Early results show a clear decrease in the fundamental frequency of the structure in a step change trend with regard to “before” and “after” the Kaikoura earthquake. Changes are estimated to be also about 15%. It’s worth noting that this analysis is only presenting changes related to one location of the instruments in the building. It is also noted that there is a small degree of recovery in stiffness the first few days following the Kaikoura event plateauing to a new normal over time.

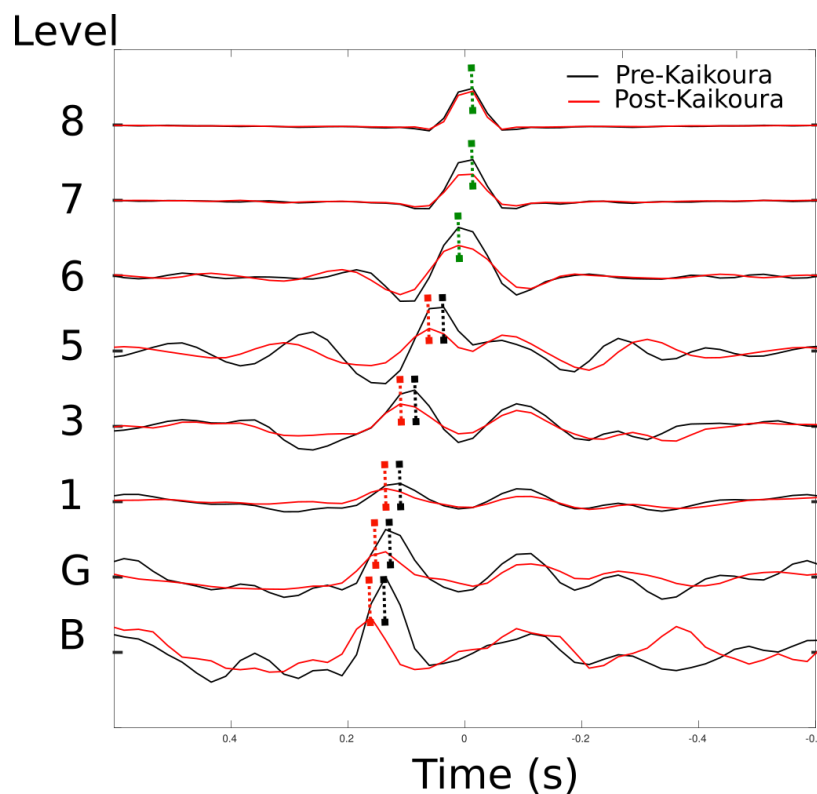
Figure 4: Stacked deconvolved traces from periods pre (black) and post (red) Kaikoura earthquake for the 325 degree direction at each instrumented level (from bottom to top trace: basement, ground level, 1, 3, 5, 6, 7 and 8) in the building derived from acceleration time-history. Dashed black and red lines mark locations of peak pulses (travelling upward) for each level and pre-Kaikoura, post-Kaikoura time periods respectively. Green dashed lines show zero time delay between red and black pulses (floors 6 to 8); black and red dashed lines show a 0.02s time delay between the red and black pulse (between floors 5 and 6), then this delay stays constant for the floors below level 5.

Focusing on the vertical array of sensors we were able to perform a deconvolution of the signals based on the signal recorded at the top and identify the floors that have changed the most (Picozzi et al. 2011; Nakata et al. 2013). We also stacked the results according to two time periods: prior to Kaikoura and post Kaikoura. Figure 4 shows the shapes of the interferograms for specific floors (basement, ground level, 1, 3, 5, 6, 7 and 8) and one specific direction (325 degrees). These interferograms represent a snapshot of the building response to a seismic pulse travelling from the bottom floor, reflected at the very top of the building and travelling back down. The interferogram of a simple structure, comparable to a homogenous block with little attenuation, will show a pulse travelling with constant propagation velocity and amplitude. However, variations in the building properties will affect the pulse amplitudes, “spurious floors” will create reflected pulses, and softening of the structure at a later time will be expressed by delays in the pulse travelling times. There is a wealth of information contained in figure 4 for the two time periods, however three principle features are noted: the overall signal shapes remain the same for both periods from levels 6 to 8 (shown by green dashed line), indicating no significant structural change. There is a clear time delay between level 5 and level 6 post Kaikoura (as shown by offset measured between red and black dashed lines) indicating that the observed changes in fundamental frequencies are concentrated between these floors. We also observe no extra time delay below level 5 (shown by constant offset between the red and black dashed lines). This change could be attributed to minor cracking of the concrete encasement encompassing the structural steel frames, and/or a softening of non-structural elements and partitions. Some damage or softening to the non-structural elements is particularly likely given that the periods recorded remain higher than that obtained from 3D analysis models of the building which do not account for the initial stiffening effects of non-structural elements. This is a preliminary analysis that needs to be investigated further with the inclusion of other available sensor data.

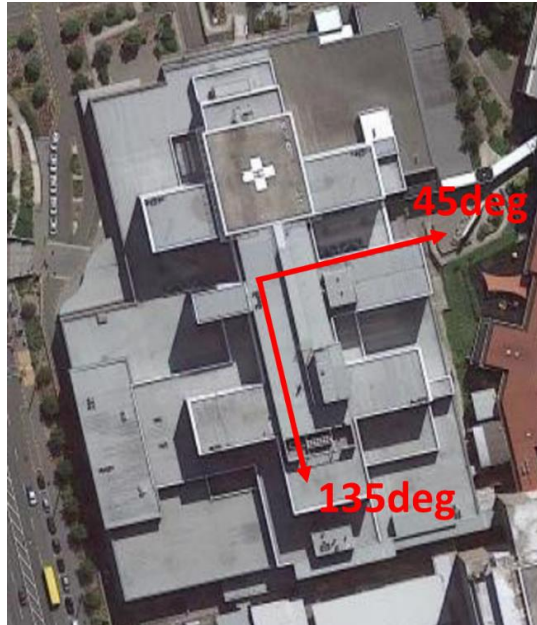
Figure 5: Plan view of the Wellington Hospital Building showing the principle component directions (Source: Google Maps)

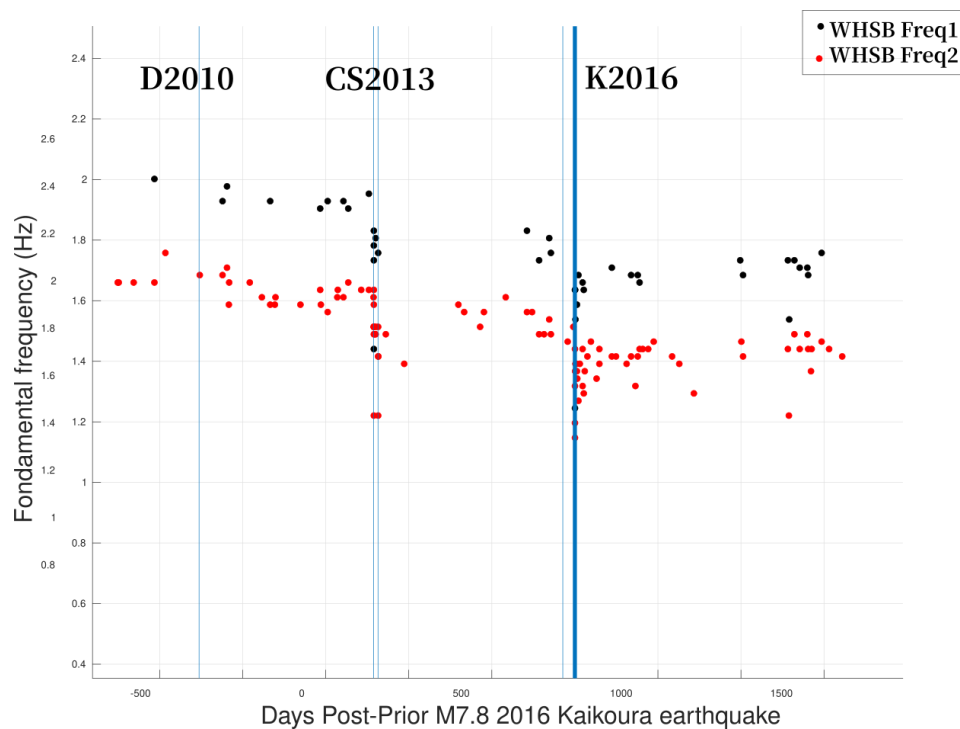
Figure 6: Measurement of the fundamental frequency of WHSB (Wellington Hospital) in the 45 degree direction (freq1 in black) and 135 degree direction (freq2 in red) against days before and after the 2016 Kaikoura earthquake (Day 0). The figure also shows significant recent earthquake timeline (blue lines): M7.1 Darfield 2010 (D2010), Cook Strait Sequence (CS2013) and the M7.8 Kaikoura earthquake (K2016)

Instrumentation of the building started in 2009. We selected a total of 903 earthquakes from 2009 to 2021. We performed a preliminary analysis of the fundamental frequencies of the structure in the main component directions of the building (45 and 135 degrees), to verify if any change could be detected over time. Figure 6 presents computed fundamental frequencies as a function of time (ie days prior to and post the M7.8 Kaikoura earthquake). The initial frequency in the transverse direction (45 degree) is about 2.0Hz (0.5sec) compared to 1.7Hz (0.59 sec) for the longitudinal direction. These differences in fundamental frequencies are not unexpected given the pronounced asymmetry of the structure.

Early results show a clear decrease in the fundamental frequency of the structure, for both directions, in a step change trend. The step changes occur following the 2013 Cook Strait sequence and the 2016 M7.8 Kaikoura earthquake. Changes are estimated to be about 10%. It's worth noting that this analysis is only presenting changes related to one particular location of the instruments in the building and that more detailed analysis is currently being done.

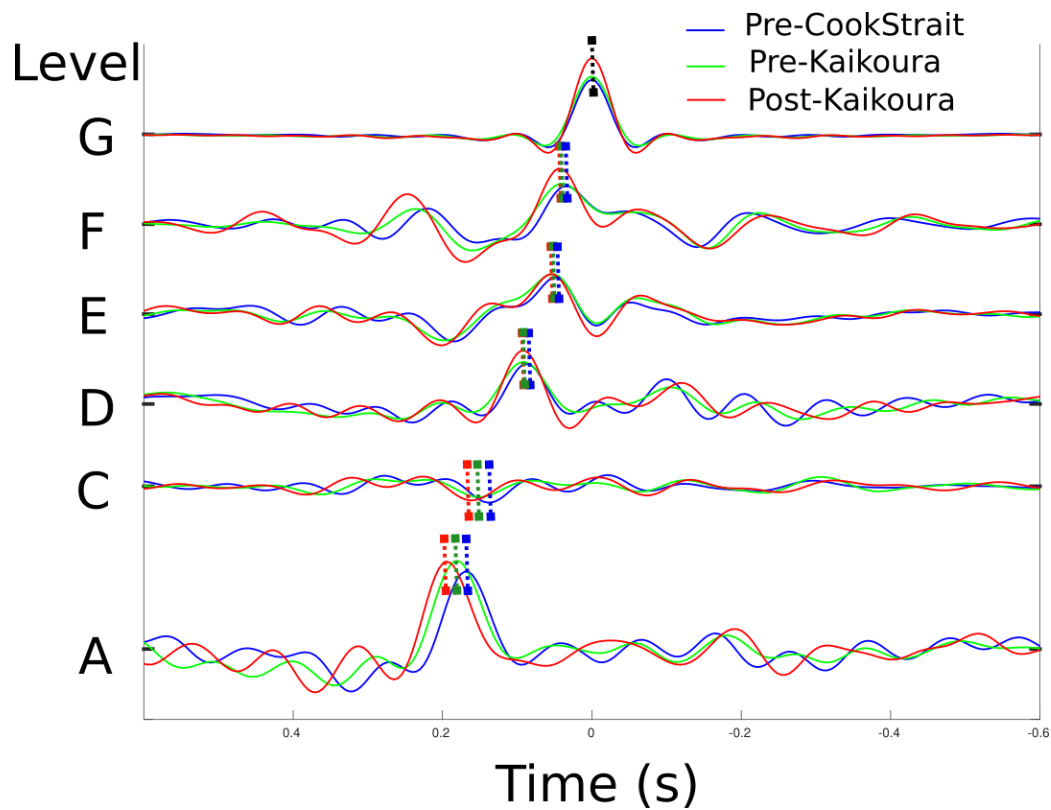
Figure 7: Stacked deconvolved traces from periods pre-Cook Strait sequence (blue), pre (green) and post (red) Kaikoura earthquake for the 45 degree direction at each instrumented level (from bottom to top trace: A, C, D, E, F and G) in the building derived from acceleration time-history. Blue, green and red dashed lines mark peak pulses (travelling upward) for various floors and pre-Cook Strait, pre-Kaikoura and post-Kaikoura time periods respectively. There are only very small pulse offset changes between these time periods for floors D to G and floors A to C. However there is a 0.03 s total offset between floors C and D following both Cook Strait and Kaikoura earthquake sequences.

As for the previous buildings, we focused on the vertical array of sensors to perform a deconvolution of the signals based on the signal recorded at the top and identify the floors that have changed the most (Picozzi et al. 2011; Nakata et al. 2013). Here we have stacked the results according to three time periods: prior to Cook Strait 2013, prior to Kaikoura and post Kaikoura. Figure 7 shows the shapes of the interferograms for specific floors (levels A, C, D, E, F and G) and one specific direction (45 degrees). Attention is focused on two principle observations: both the Cook Strait sequence and Kaikoura earthquake impacted the structure, and the majority of the observed change appears to have occurred between levels C and D. The change in fundamental frequency as noted in Figure 6 is therefore attributed in principle to the concentrated impact observed between level C and level D.
