Retrofit and Repair of Reinforced Concrete Columns with Active Confinement

J. Rincón & S. Pujol

University of Canterbury, Department of Civil and Natural Resources Engineering, Christchurch.

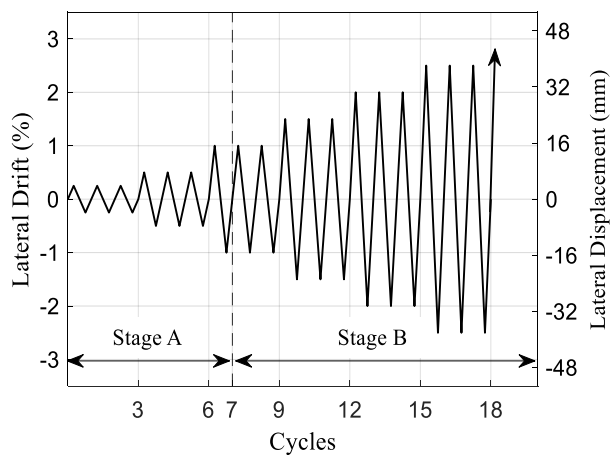
Figure 3: Loading protocol

Figure 3 shows the loading protocol. The columns were subjected to three lateral cycles at every target drift ratio until the lateral-load carrying capacity decreased by more than 50% of the maximum reached at any previous cycle.

Columns C10 and C11, which were used to test the clamps as repair measure, were loaded in two stages, A and B. Stage A consisted in applying three cycles at 0.25% drift and 0.5% drift, and the first cycle at 1% drift. The intent of Stage A was to cause initial damage represented in flexural and shear cracks. Columns had no post-tensioned clamps during stage A. After initial damage, the columns were repaired by furnishing them with clamps. Then, stage B of the loading protocol was applied until end of test.

Before application of clamps, during stage A of the loading (Fig. 3), damage in columns C10 and C11 consisted in flexural cracks and a critical shear crack. A critical shear crack is defined here as a crack that occurs before flexural cracking in its vicinity. The observed flexural cracks, which were up to 0.45mm thick, occurred in a similar fashion in C10 and C11. The maximum thickness of the critical shear crack in C10 and C11 was measured as 4.0 mm and 1.0 mm, respectively. When such crack was observed, lateral loading was stopped and axial load was removed. Then clamps were mounted and prestressed. Clamping was conducted in less than 4 hours, and columns were tested the day after when axial load was reapplied. Table 3 summarises key test variables and results. Figure 6 shows the hysteretic responses of columns C10 and C11, before repair (Stage A), and after repair (Stage B).

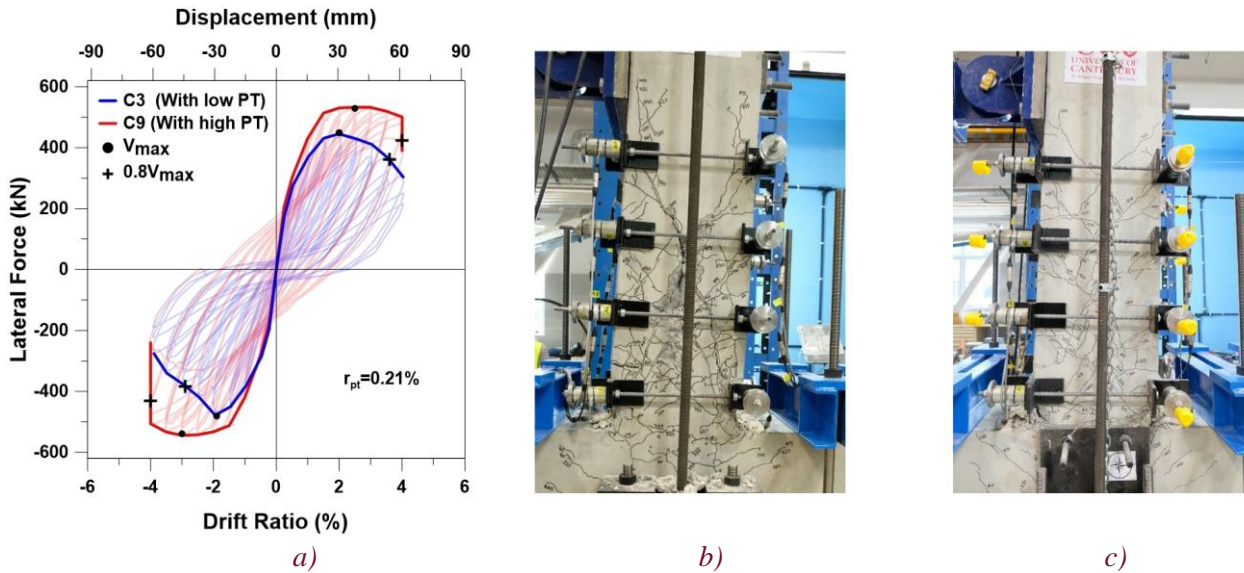
Figure 4a shows the hysteretic response of columns C3 and C9. The expected maximum lateral load V_p during the test was 510 kN and the associated unit plastic shear stress v_p was 2.4 MPa. The maximum measured lateral load resisted by C3 ($\sigma_L = 0.2$ MPa or $0.04\sqrt{f'_c}$) was 480kN and the associated unit shear stress v_{max} was 2.3 MPa or $0.41\sqrt{f'_c}$. It is inferred that C3 did not reach flexural yielding of the longitudinal reinforcement and the mode of failure was driven by a gradual disintegration of the concrete core (Figure 4b). The drift capacity of C3 was 3.0%.

Compared with C3, column C9 ($\sigma_L = 1.1$ MPa or $0.23\sqrt{f'_c}$) had a drift capacity of 4% and a more stable response. C9 resisted a maximum applied lateral force of 540 kN ($v_{max} = 2.5$ MPa or $0.53\sqrt{f'_c}$). C9 not only reached flexural yielding of the longitudinal reinforcement (at a drift ratio close to 1.5%), but its response post-yielding was more ductile than C3. Before failure, fewer and narrower cracks were observed in C9 than in C3 (Figure 4c). Lateral prestress caused by the clamps on C9 precluded the formation of large, inclined shear

cracks observed in C3. In addition, the lateral prestress increased the drift capacity from 3% (C3) to 4% (C9), which is a relative increase of 33%.

Figure 4: a) Hysteretic response of columns C3 and C9; b) Column C3 at a drift ratio of 3.5%; c) Column C9 at a drift ratio of 3.5%

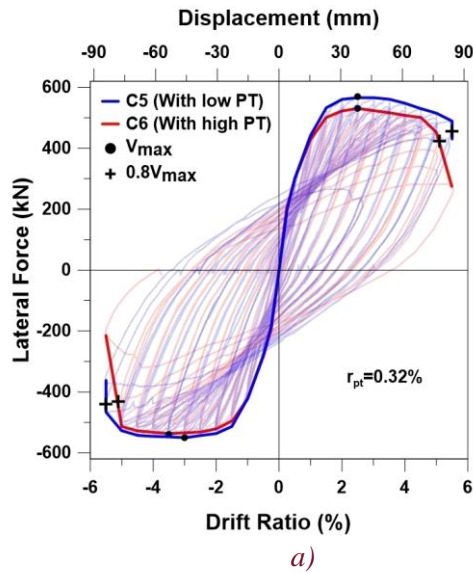
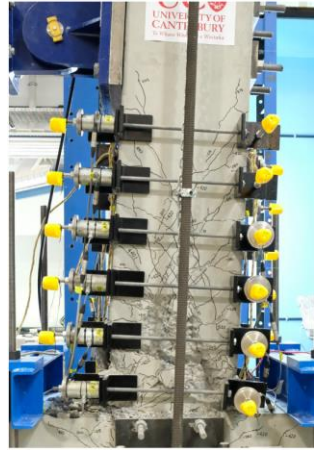
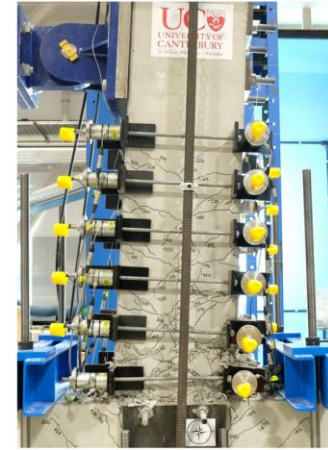
The measured hysteretic responses of columns C5 ($\sigma_L = 0.3 \text{ MPa}$ or $0.05\sqrt{f'_c}$) and C6 ($\sigma_L = 1.7 \text{ MPa}$ or $0.35\sqrt{f'_c}$) are shown in Figure 5a. Both columns reached flexural yielding at a drift ratio of 1.5%, approximately. The maximum measured shear force resisted by C5 was 570 kN ($v_{max} = 2.7 \text{ MPa}$ or $0.45\sqrt{f'_c}$). The drift capacity of C5 was 5.5%. Column C6 resisted a maximum applied lateral force of 540 kN ($v_{max} = 2.5 \text{ MPa}$ or $0.51\sqrt{f'_c}$). The drift capacity of C6 was 5.0%.

Column C5 maintained its lateral resistance during the first cycle at a drift of 5.5%. Nevertheless, a large inclined crack, spanning from the second clamp (from bottom) to the base of the column, caused a rapid disintegration of the concrete core. In the third cycle at a drift ratio of 5.5%, the column slid along the mentioned crack, triggering an abrupt loss of the lateral-carrying capacity.

Reaching a drift capacity of 5%, Column C6 failed in a mechanism controlled by flexure rather than by shear. Fewer cracks were observed in this test unit than in C5 (Figure 5b). For C6, severe deterioration of the concrete was observed in the compression zones (Figure 5c). It is plausible that this deterioration (that was not as clear in C5) was related to the weaker concrete strength of C6. C5 had $f'_c = 36 \text{ MPa}$, whereas C6 had $f'_c = 24 \text{ MPa}$. Differences in f'_c occurred because 1) the quality control at the mixing plant did not allow for more uniform values of f'_c , and 2) the specimens were cast from different concrete batches reportedly made using the same mix design.

Figure 5: a) Hysteretic response of columns C5 and C6; b) Column C5 at a drift ratio of 5.5%; c) Column C6 at a drift ratio of 5.5%

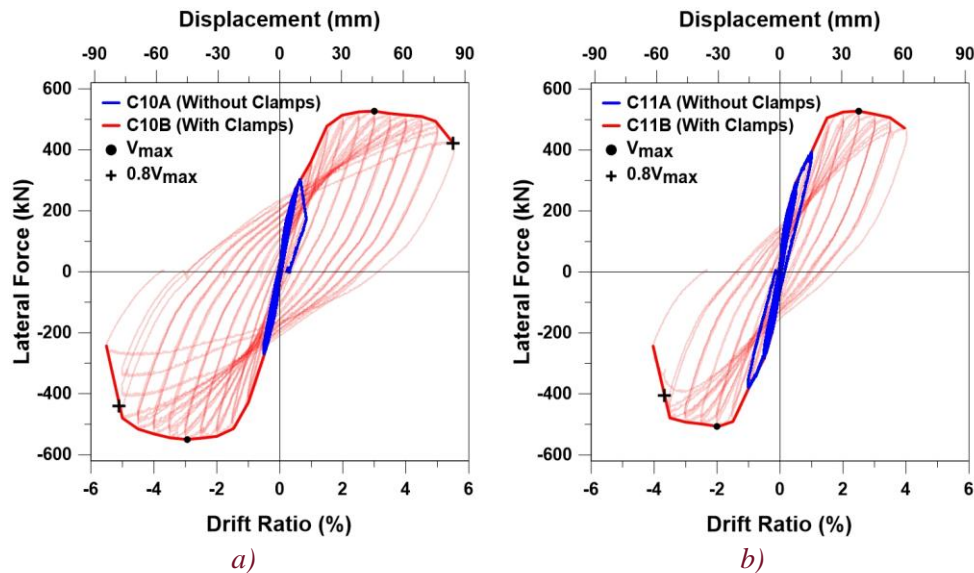
Figure 6: Hysteretic responses of test columns: a) C10 and b) C11.
