Innovative Retrofit Solution for Exterior Unreinforced R.C. Beam-Column Joints

In this paper, an innovative retrofit approach is investigated using a bidirectional test on a corner beam-column joint with the aforementioned deficiencies, based on a 1930s RC frame building in Wellington, NZ. This retrofit uses drilled and epoxied reinforcement bars at the face of the joint to increase the tensile strength of the joint and prevent the concrete wedge spalling failure.

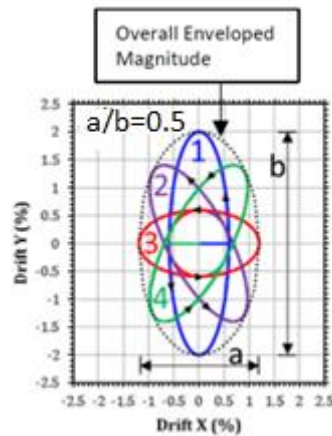
Figure 3: Loading protocols proposed by Raza et al. for bidirectional loading (Raza 2019).

Figure 2 illustrates the schematic test setup and loading system. In this setup, beam and column elements were extended to the contraflexure point with pin connections. Bi-directional inter-storey drift was applied through the horizontal hydraulic actuator at the top of the column. An octo-elliptical loading pattern with an aspect ratio of 0.5 was applied as per the suggestions by Bueker et al (Raza 2019), as illustrated in Figure 3.

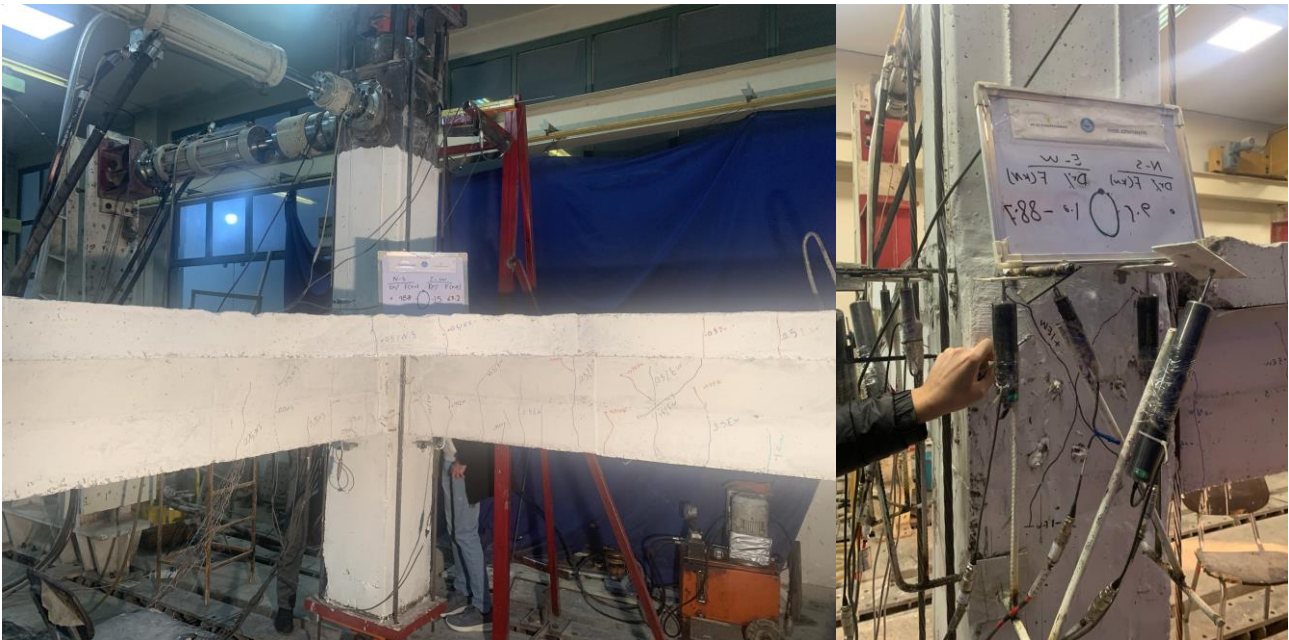
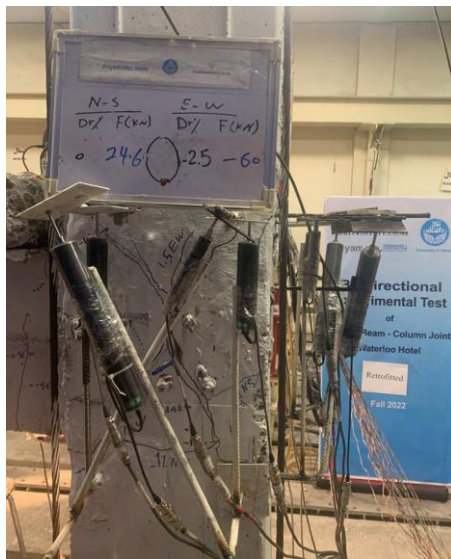
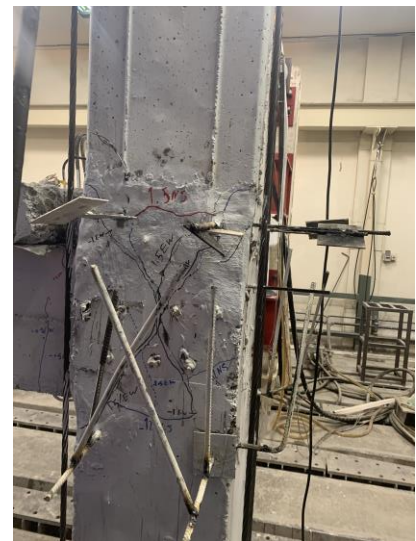
Figure 6: Observed cracking pattern of E-W cycle of a) +01.5%; b) 1.5%; c) +2.5% and d) end of test 3.2%

During the testing, flexural cracks on the beams start to form at a drift ratio of 0.25% and continued to increase at 0.5% drift. A vertical crack was opened at the beam-column interface at 0.5% drift. Diagonal cracking of the joint in the E-W direction formed at 1% drift and was opened to 1.5mm at 3.2% drift. No joint strength degradation was observed up to 3.2% drift. The test was terminated at 3.2% drift as there was minor misalignment in the embedded plate which transfers the load from the actuator and there was a concern this would induce torsion at high levels of drift.

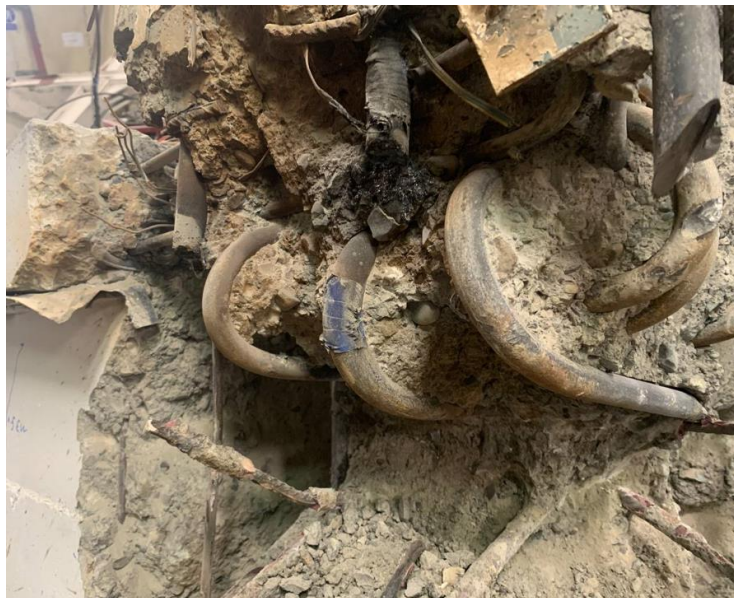
Figure 8: The beam-column joint after demolition

Following the test, the beam column joint was demolished to investigate any potential cracking at the end of the hooks which would suggest bar slippage. As seen in Figure 8, no separation between concrete and reinforcing bars was observed at the end of the hooks.
