Deformability of lap splices in RC structural walls

C. Kerby & S. Pujol

University of Canterbury, Christchurch

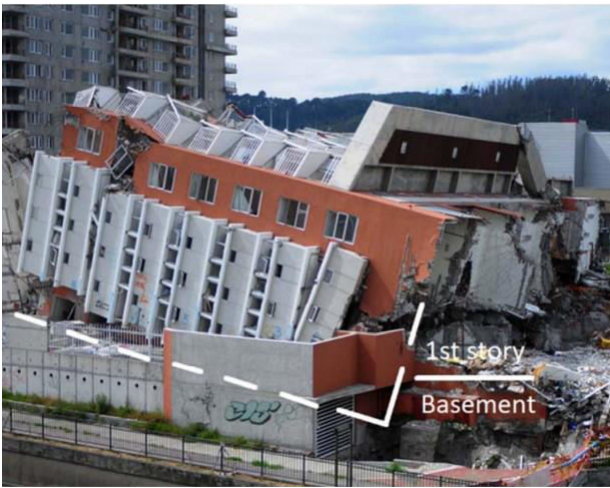
Figure 2: The Alto Rio building after the 2010 Maule, Chile Earthquake (Song et al., 2012)

Table 1 provides a list of notable post-earthquake observations of damages to structures associated with lap splices. The most infamous of this list are the total collapses of the Alto Rio Building during the 2010 Maule earthquake (Figure 1) and the Four Seasons Apartments during the 1964 Anchorage earthquake (Figure 2). Lap splices were not always the exclusive reason for the listed failures but were major contributors in all cases. In structures that do not collapse, damages associated with lap splices can justify demolition.

Maule, Chile	2010	Song et al. (2012)	Alto Rio Building	Separation of building from foundation leading to total collapse. Both lap splice failures and bar fractures occurred
		NIST (2021)	Festival Building	Boundary element lap splice failure
			Emerald Building	Spalling of concrete along exterior wall lap splice length
Canterbury, NZ	2010 - 2011	Sritharan et al. (2014)	Terrace on the Park Apartments	Reinforcement buckling wall failure, concentrated about the first-floor splice region. Lap splices of horizontal reinforcement failed away from the wall base
Meinong, Taiwan	2016	NCREC and Purdue (2016)	泰慶天廈 / King's Town High-rise	Spalling of concrete along first-floor wall lap splices

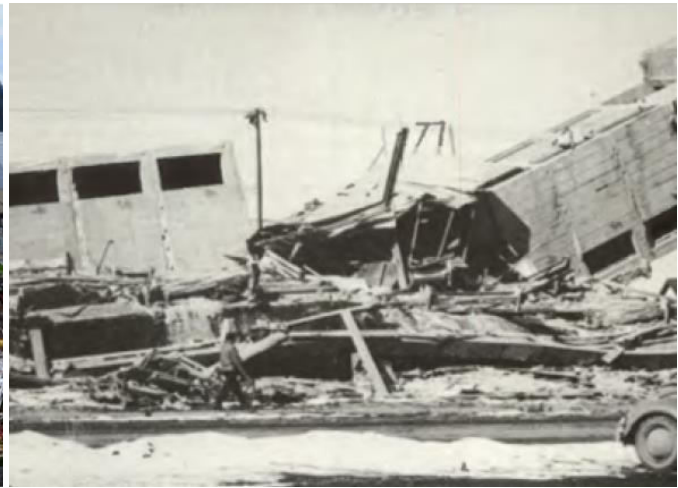
Figure 2: The collapsed Four Seasons Apartments after the 1964 Anchorage (USA) earthquake

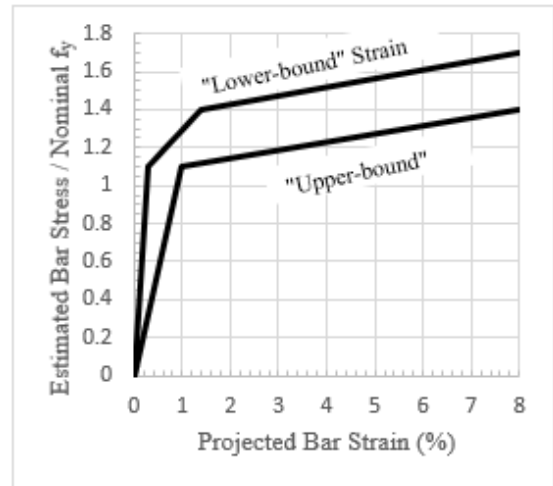
Figure 5: Ratio of estimated bar stress to nominal reinforcement yield stress (f_y) versus lower- and upper-bound lap spliced bar strains determined by Pollalis (2021)

where l_s is the length of the splice; d_b is the diameter of longitudinal bars being developed; f_{bc} is the concrete contribution to bond strength; k_{ts} is a factor related to the magnitude of the peak bond stress expected along the splice (varying between 0.9 – 1.2 for the walls of Table 2); and k_{sf} is a factor relating to the location of the peak bond stress (between 1.5 – 6.9). Lower- and upper-bound limiting splice strains are estimated according to Figure 5 and the result for Equation 2. The average of the bounding strains obtained

from Figure 5 was used to estimate φ_u and DC for the walls in Table 2. Alternatively, a different expression for f_s and stress-strain curves from tensile tests of reinforcement could be used to achieve a similar result. It is assumed in this discussion that the reinforcement properties of the walls in Table 2 are unknown. As presented here, Pollalis' method produced lower-bound estimates of drift capacity (Figure 6b). 17 of 18

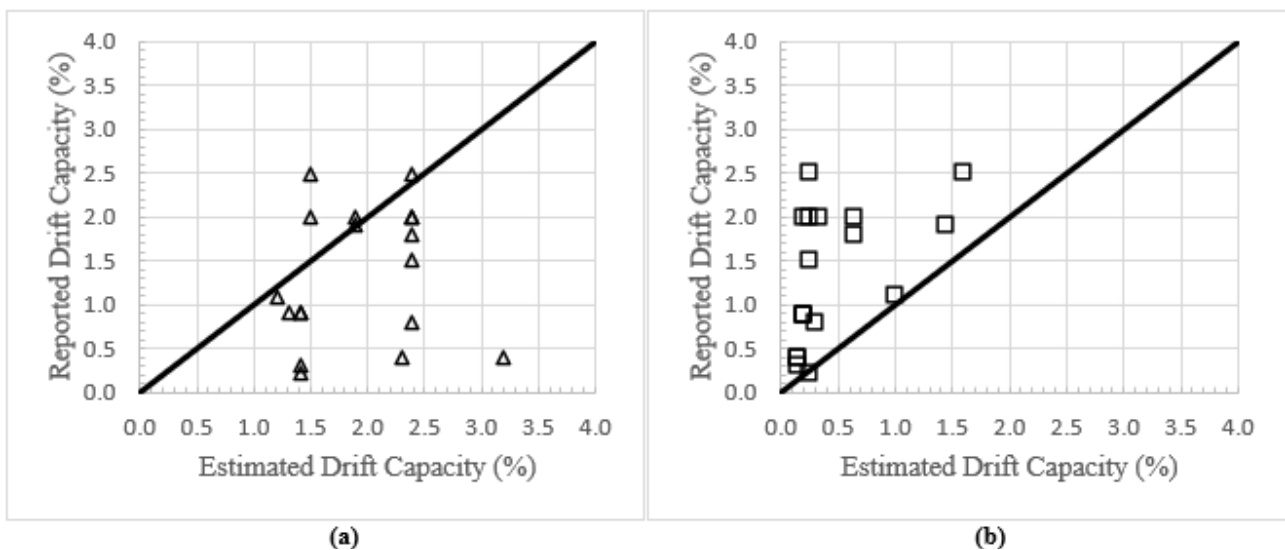
Figure 6: Reported drift capacity (%) from 18 tests of slender RC walls with non-staggered lap splices vs drift capacity (%) estimated using (a) Equation 1 and (b) Pollalis' method

(ε_{cu}/c); l_p is the length of the plastic hinge, assumed to be half the length of the wall; c is the neutral axis depth from moment-curvature analysis; and ε_{cu} is the assumed limiting concrete compressive strain considering the effect of confinement (Puranam et al., 2018). Equation 1 produced unreliable, non-conservative estimates of DC for 13 of 18 wall tests (Figure 6a). Especially for wall specimens that failed in bond, Equation 1 grossly overestimated DC .

estimates of DC were conservative with 13 of 18 estimates being smaller than half the reported drift capacity. The method estimated lower bounds for DC , but the Figure 6b suggests it may be too conservative to be used in design.
