# Developing guidelines for the seismic assessment of glazing systems

*F. Arifin, G. De Francesco, T.J. Sullivan & R.P. Dhakal*

University of Canterbury, Christchurch.

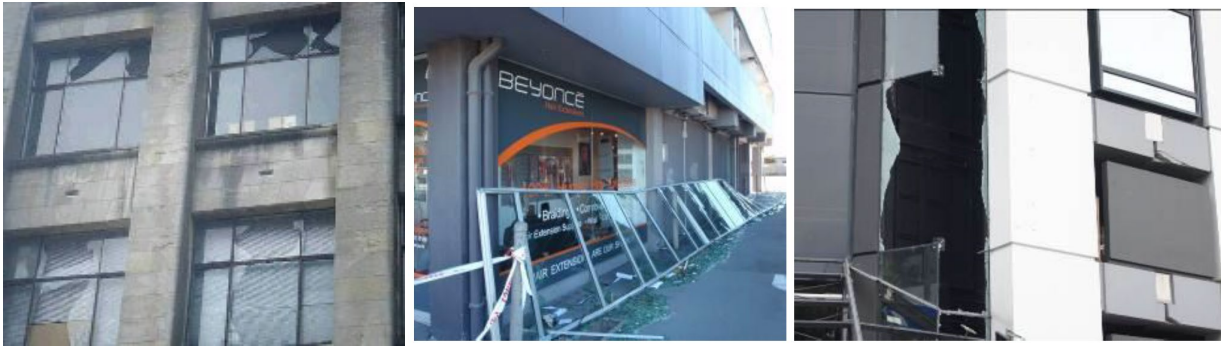
*Figure 1. Examples of glazing damage that occurred in the September 4th 2010 Darfield earthquake (Dhakal 2010) and the February 22nd 2011 Christchurch earthquake (Baird et al. 2011).*

Recent events, such as the 2016 Kaikōura earthquake and the 2010-2011 Canterbury earthquakes, have highlighted the damage earthquakes cause to glazing systems (Dhakal 2010, Baird et al. 2011). Figure 1 illustrates damage to glazing observed from the Canterbury earthquakes. Photos in the press (Stuff, 2017) of shattered glass on footpaths and reports that areas may be cordoned off because of the risk posed by falling glass remind us that the performance of glass windows/glazing in earthquakes can be a life-safety matter. There were many reports of injuries due to broken glass lying in egress routes following the Canterbury earthquakes. In addition, the repair of glass facades can be costly and time-consuming and accessibility to damaged parts can pose a significant challenge in many cases. Following the Kaikōura earthquake, due to the complexity of the repair work (including access) glazing repairs in downtown Wellington reportedly cost as much as \$50,000 per pane (Valli, 2017).

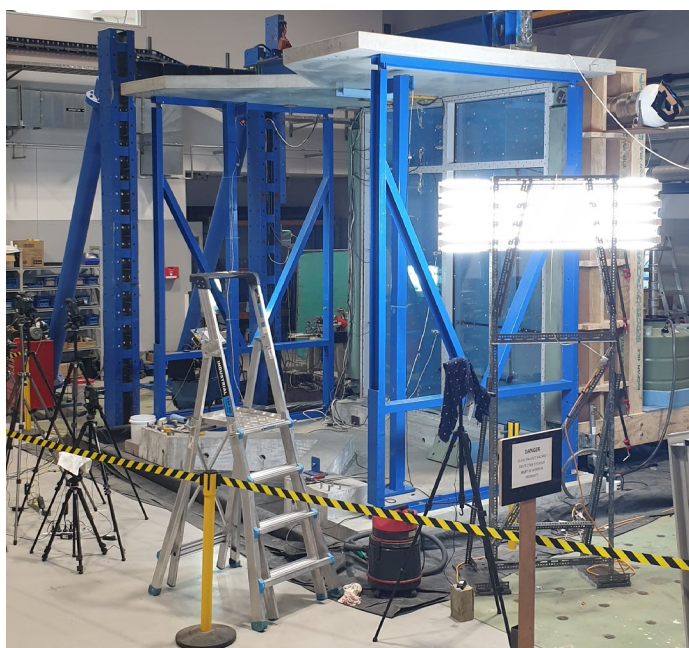
*Figure 2. Experimental set-up for testing of glazing systems in commercial buildings; showing concrete slabs, support frames, timber box and glazing specimen.*

The experimental set-up (Figures 2-5) consists of two concrete slabs (top and bottom), simulating building floors with a height of 3.6m, which were erected with two pinned steel frames at either end. The structure is fully pinned in the longitudinal direction and is not permitted to move in the orthogonal direction. The rig is connected to a hydraulic actuator which can impose roof displacements of  $\pm 300\text{mm}$  in the longitudinal direction and a force of 800kN. Two additional steel columns are added in the longitudinal direction to simulate floor columns creating an “opening” of 2.976m long by 3.385m high for installing the glazing system. A full-scale glazing system specimen is then installed in the opening which is then sealed on all four sides to ensure realistic building conditions. During the water penetration test, a weather simulator “box” made from timber is attached to the system fully covering the glazing system. An array of sprinkler nozzles 1800mm apart is mounted inside the timber box which is approximately 900mm deep as recommended by NZS4211. Water is then “sprayed” onto the glazing system simulating rain. This system is designed as such that after falling off the face of the glazing, the drained water is reticulated back to the water reservoir (via a pump). Furthermore, to simulate wind, an air blower is utilized to increase the air pressure inside the “box”. The air pressure could then be controlled via a differential pressure sensor and two “air bleeding” valves.

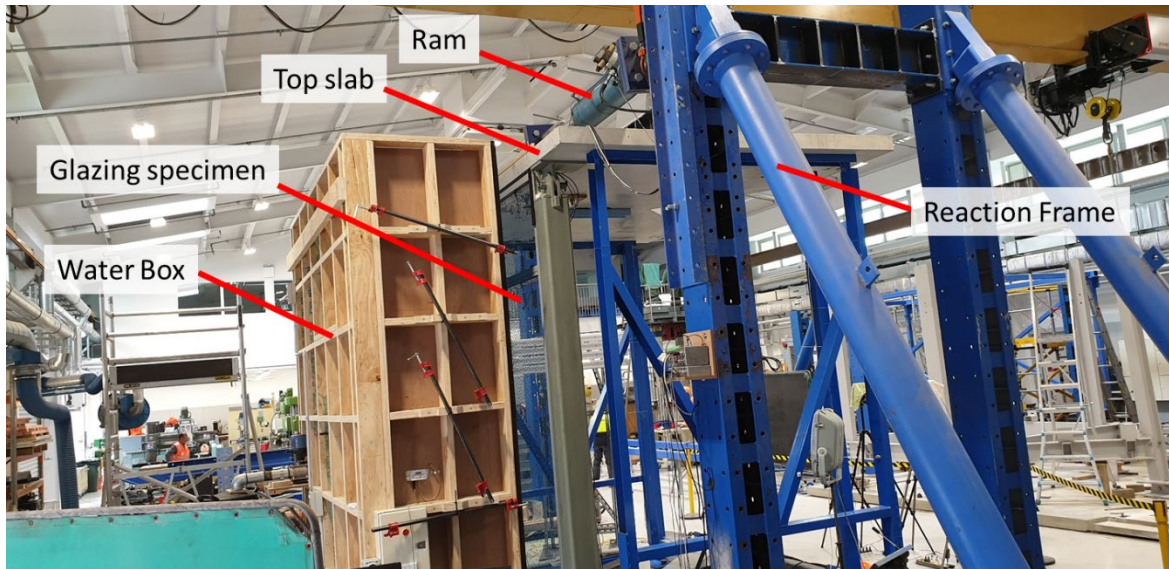
Figure 3. Photo of water box, actuator, reaction frame and ram.

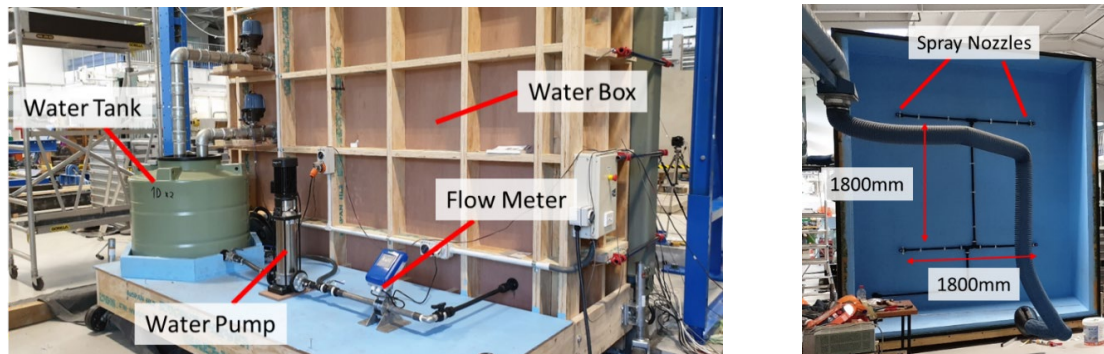
Figure 4. Equipment required for water-tightness test. View from rear (left) and view of spray nozzle locations inside box (right).

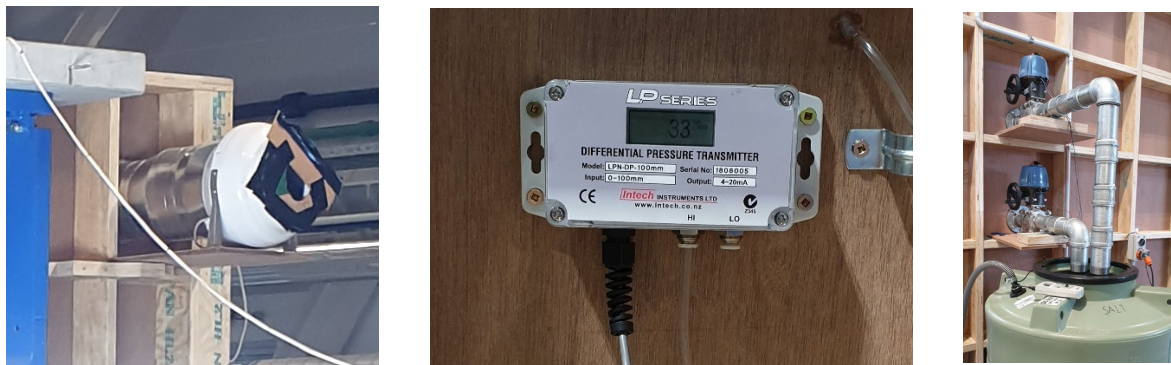
Figure 5. Air pressure control unit. Air blower (left), differential pressure sensor (middle) and bleeding valves (right).

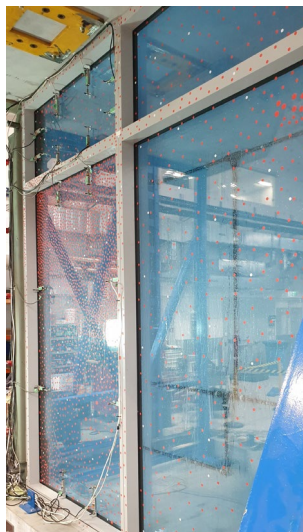
Figure 6. Glazing Specimen.

The first set of specimens are a common dry glazed curtain wall glazing system with four panes (Figure 6). The two bottom panes had small aspect ratios of 1.426m wide:2.56m tall and the other two top panes had larger aspect ratios of 1.426m wide:0.622m tall. The framing was made from aluminium which provided a glass clearance of 16mm. The aluminium frame is screwed on all four sides to the concrete slab and steel columns. The system is sealed with PVC wedges around all four sides of each glass pane and silicone around all four sides of the aluminium (two sides in contact with concrete, and two in contact with steel).

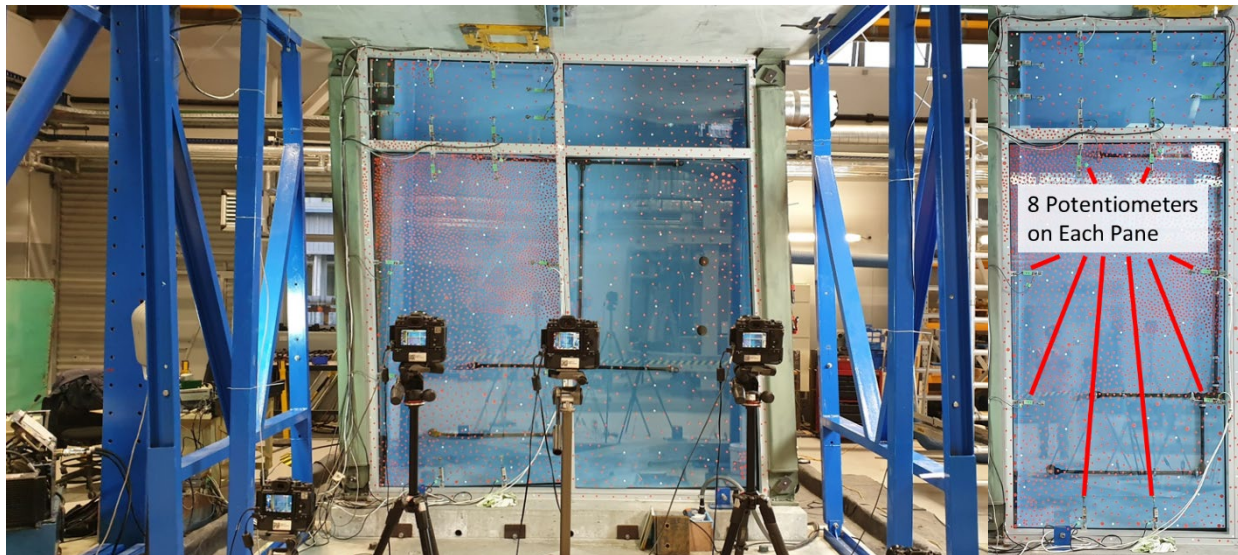
The rig was instrumented with a load cell to measure the force resisted by the actuator, a displacement transducer to measure the roof displacement, particle dots for particle tracking of the glazing system, and potentiometers to collect data on the rigid body movement of the glass pane with respect to the aluminium frame.

Figure 8. Photo showing glazing specimen and instrumentation used in the experimental testing, cameras and red dots used for particle-tracking (left) and potentiometers used to monitor displacements of panes relative to framing (right).

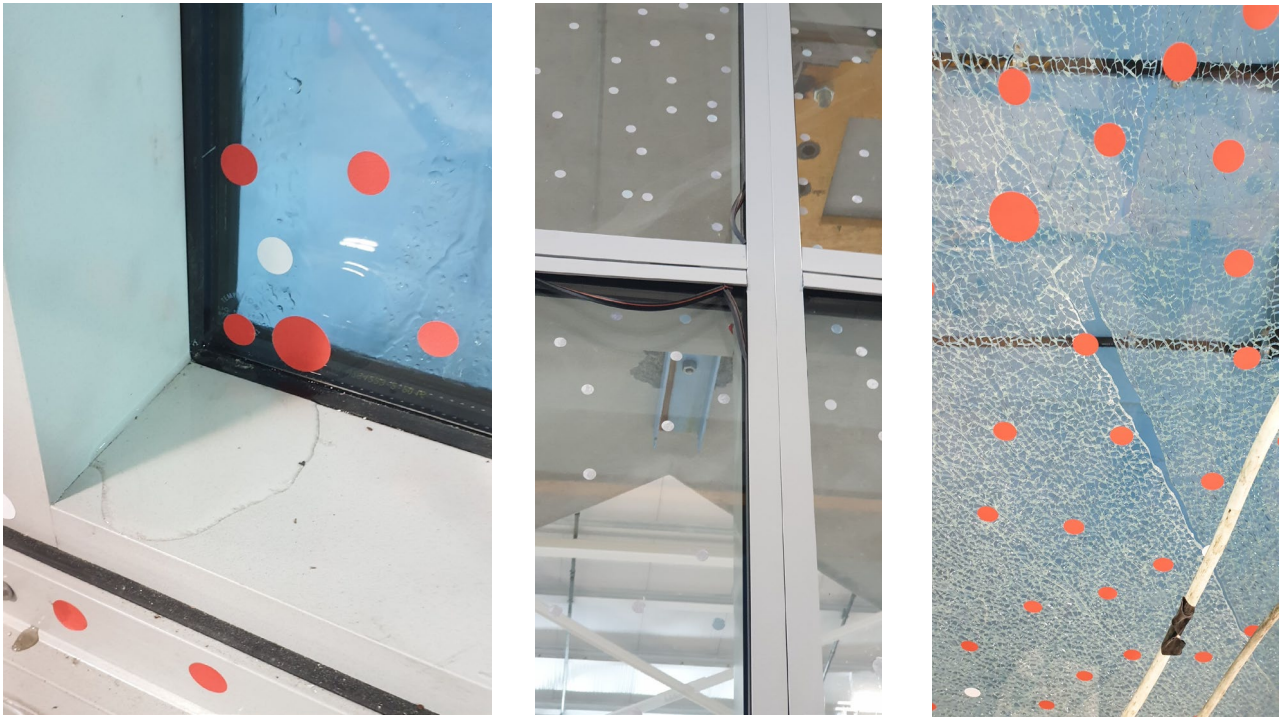
Note that three damage states are considered for the tabulation of data, which are; DS1: loss of the water-tightness of glazing units, judged to occur when water first appeared on the inside face of the glazing (Figure 9); DS2: visual gasket failure in which gaskets were seen to have moved out of place (either jammed into framing or falling out) and would have prompted repair (Figure 9); DS3: failure of the frame or glass (either significant cracking or fall-out) (Figure 9).

Figure 9. Damage states 1-water leakage(left), 2-gasket failure(middle) and 3-glass or frame failure(right).
