Adequacy and retro-fitting of timber frame house foundations on slopes

G.C. Thomas

R.H. Shelton

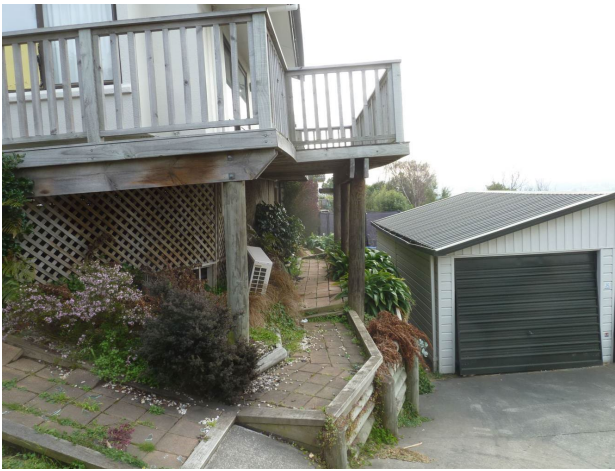
Figure 1: Tilting pole structure

Previous studies and observations from the Christchurch Earthquake of 2011 summarised in a previous paper (Thomas et al 2019) have indicated that there are significant issues with the structural strength and stability of many existing house foundations and other light timber frame buildings on sloping sites. Pile or poles rotate downslope as shown in figure 1, if their embedment length, footing diameter is too small, or the soil is too weak to take the imposed loads. Foundation walls may also displace downslope (figure 2.).

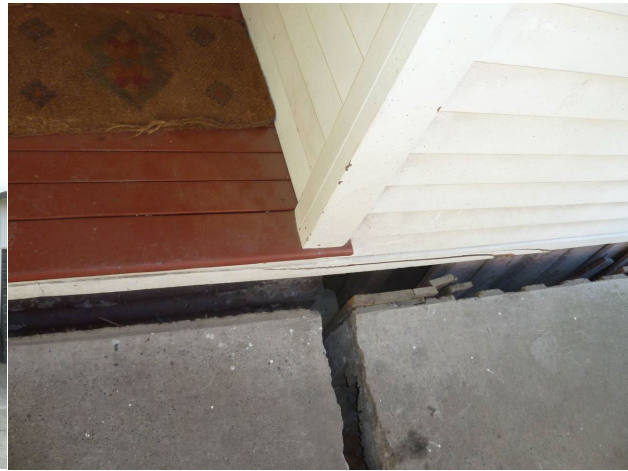
Figure 2: Downslope displacement of uphill foundation

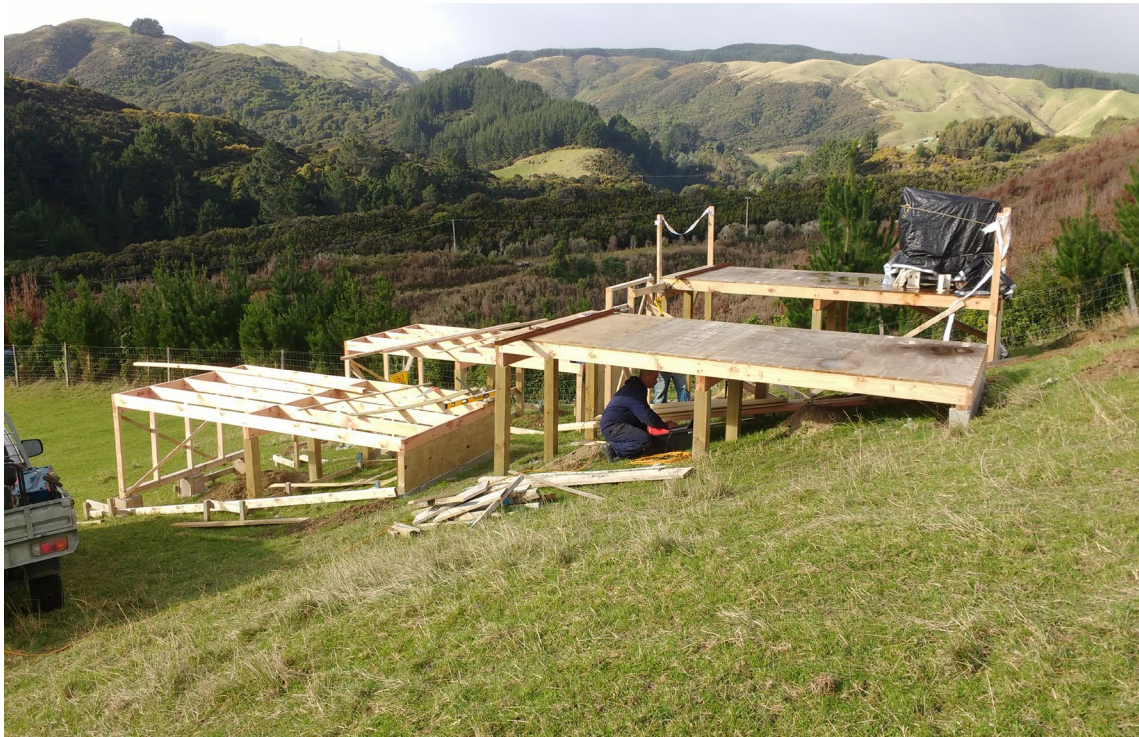
Figure 3: Photograph of overall set-up. NZS 3604 floors on right, pre-1960 floors on left.

Each test specimen consisted of a timber framed and overlaid floor of approximately 2.4m across slope by 4.8m up and down the slope. Such a size allows the inclusion of either piles at the four corners or a combination of piles and foundation walls, and the larger uphill length will allow for torsional effects from varying foundations stiffness on the uphill and downhills to be considered. Additional dead weight was added to the floors of the specimens to replicate the true mass of the superstructure associated with the supporting foundation. Figure 3 shows the setup of the specimens on the hill and details of the specimens are shown in figure 4 and in table 1.
